Artistry and Ingenuity of Gothic Vaults at the Example of St. Georg in Nördlingen

Rainer Barthel, Helmut Maus and Matthias Jagfeld

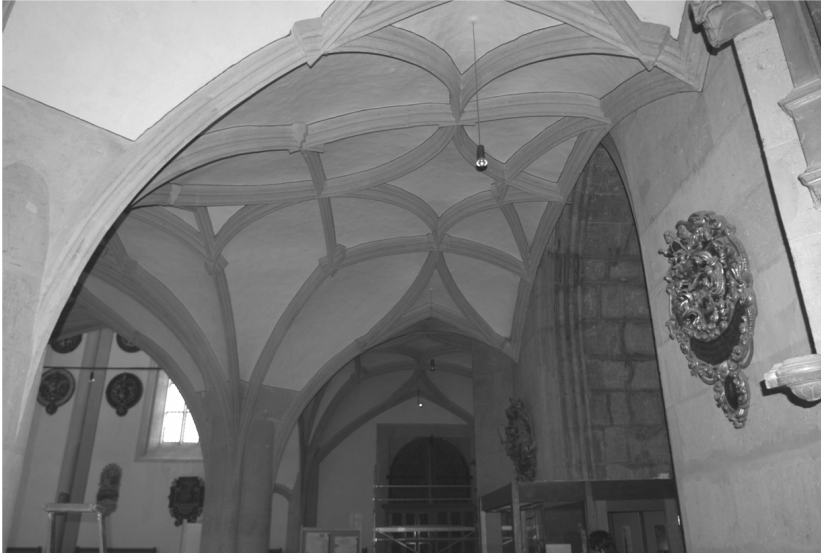
Figure 7. Gallery's central vault at the main gate

The western vault ends at walls of the tower (**fig.7**). The apex of the central vault does not reach the height of the main gate. Therefore, the vault has a free-spanning fringe of about 4 metres length. In this area, it is supported neither in vertical nor in horizontal direction which renders necessary a special stabilizing construction.

The examinations were prompted by damage and deformation of the arch beside the tower wall. The arch had lowered and showed deformations in direction of the open main gate.

The rib arches showed damage on the bottom side, near to the apexes, in form of deep, gaping fissures at the joints. On the supports at the tower's walls spalling and longitudinal fissures in the ribs were apparent. This indicated a horizontal displacement of the supports. Vertical cracks in the tower's walls indicated that the tower's northern and southern foundations had drifted several millimetres apart. These deformations may have happened soon after the erection of the tower. The flat arch reacted highly sensitive to the supports' displacements: the apex had dropped about 50 millimetres. The original shape was ascertained from the ridge rib's curvature.

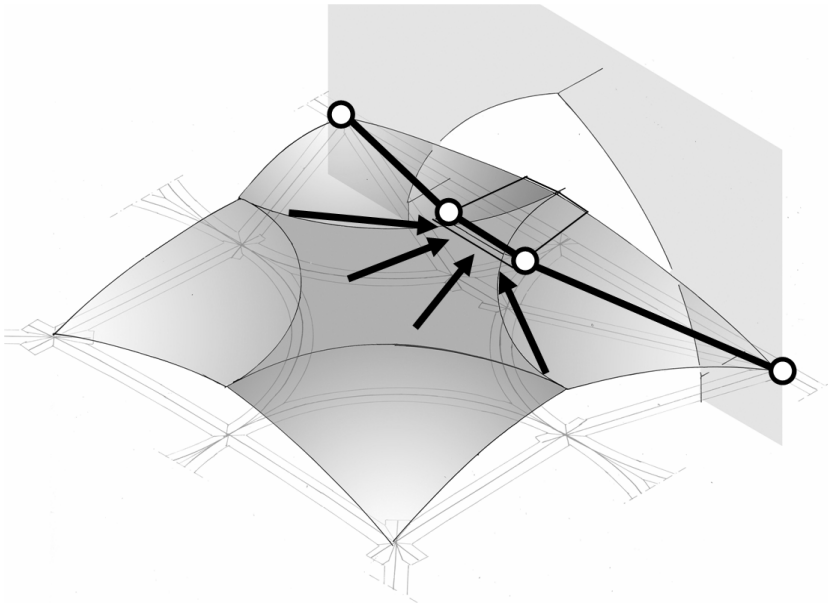
Figure 8. "Strutted frame" at the main gate

- 1) The additional ribs form a strutted frame. This frame is able to transfer the vault's horizontal forces to the tower (**fig.8**).
- 2) The frame's "keystone" is formed in a special way. Its size is 0.80 by 1.30 metres and it is completely embedded in the vault's brickwork. The ribs on its bottom side are carved out of the monolithic stone. Stretching to the bay's free-spanning fringe, the stone has the function of a tension tie. It stabilizes the ribs on the fringes and ties them horizontally to the strutted frame (**fig.8, 9, 10**).

Simultaneously, the span of the "strutted frame" had widened. As a result, it gave way and the keystone shifted horizontally in direction of the main gate (**fig.12**). Accordingly, the bent rib's joints showed gaps and spalling. The result was a complex state of deformation.

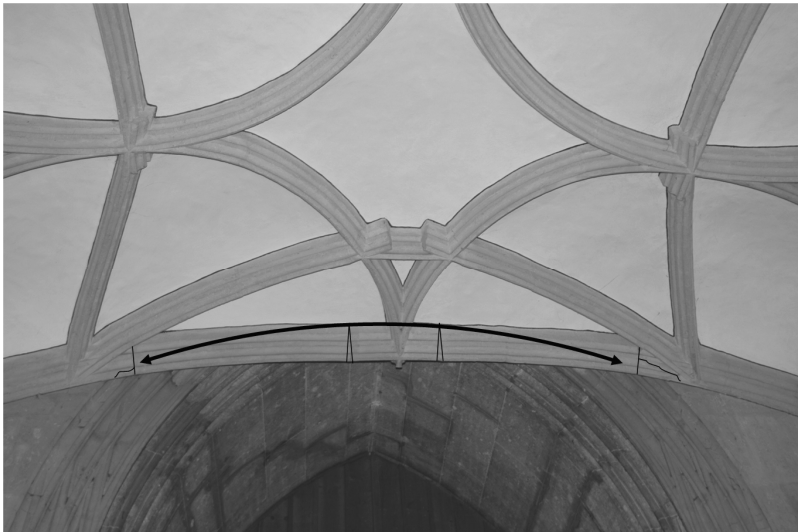
The pressure on the ribs' edges resulted in spalling and fissures on the arch's supports. In that area, the profile was already thoroughly damaged (**fig.11**). With another minor displacement of the walls or additional loads, the heavy keystone might have given way.

Figure 11. Deformed arch at the main gate with marked joints and the resulting thrust line

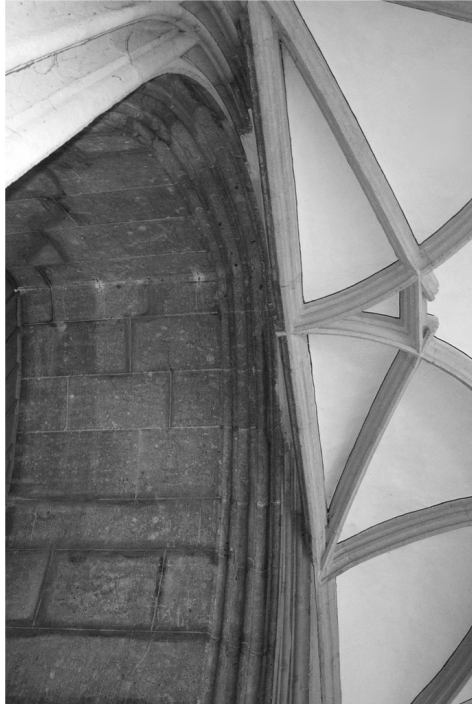
Figure 12. Horizontal deformation of the edge rib at the main gate

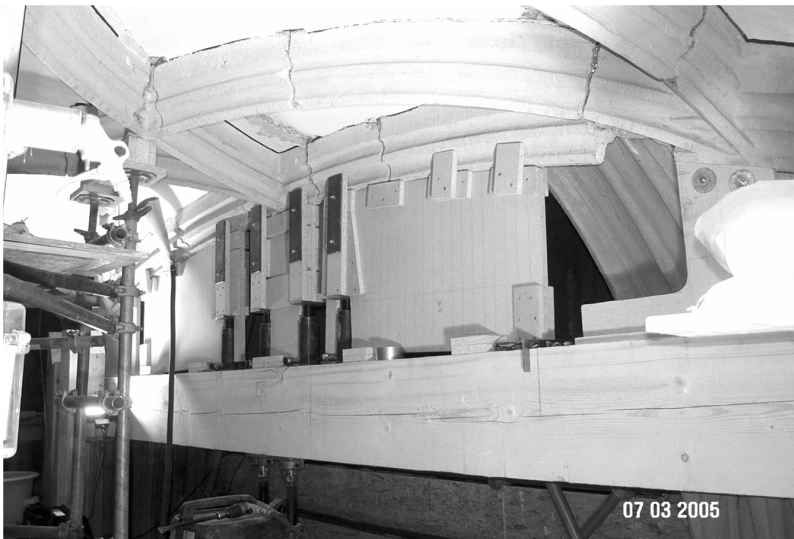
Figure 13. Raising of the central vault

In the end the decision was made to raise the whole area back into its initial position necessitating the erection of scaffolding under the vault. The vaulting could then be lifted vertically on jacks (**fig.13**). During the process, the keystone had to be supported in its horizontal position. The rib joints opened during the operation. "Leaden wool" was pressed into the open joints. The damaged parts of the ribs were then replaced. During the operation, a number of cracks appeared in the brickwork above the rib structure. They formed a regular pattern that corresponded to the calculations. The straight-formed "backsides" of the ribs became clearly visible. All cracks and fissures were filled with a special mortar from above.

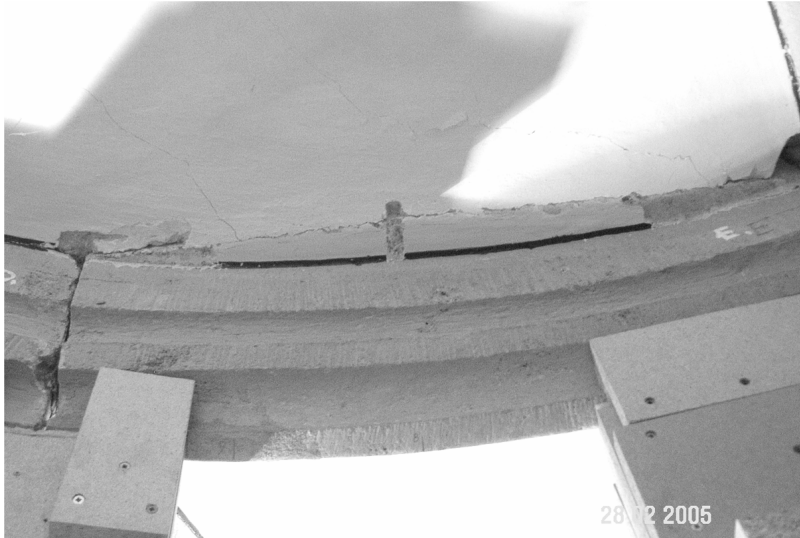
- 3) It was a surprise to detect that the vault's bent ribs are also carved out of larger, straight-formed workpieces (**fig.14**). These stones are also embedded into the brickwork. Only their visible part has a bent shape. Therefore, bending moments in the rib can be avoided. Additionally, the embedding in the brickwork enables the rib to support the vaulting horizontally.

Figure 14. Bent rib with straight, embedded backside
