Artistry and Ingenuity of Gothic Vaults at the Example of St. Georg in Nördlingen

Rainer Barthel, Helmut Maus and Matthias Jagfeld

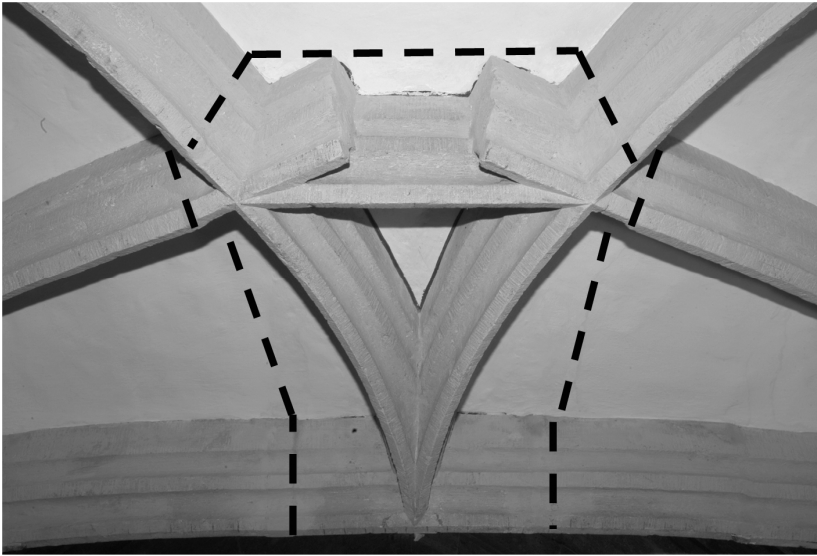
- 1) The additional ribs form a strutted frame. This frame is able to transfer the vault's horizontal forces to the tower (**fig.8**).
- 2) The frame's "keystone" is formed in a special way. Its size is 0.80 by 1.30 metres and it is completely embedded in the vault's brickwork. The ribs on its bottom side are carved out of the monolithic stone. Stretching to the bay's free-spanning fringe, the stone has the function of a tension tie. It stabilizes the ribs on the fringes and ties them horizontally to the strutted frame (**fig.8, 9, 10**).

Figure 9. Keystone at the main gate with marked limitations

In the end the decision was made to raise the whole area back into its initial position necessitating the erection of scaffolding under the vault. The vaulting could then be lifted vertically on jacks (**fig.13**). During the process, the keystone had to be supported in its horizontal position. The rib joints opened during the operation. "Leaden wool" was pressed into the open joints. The damaged parts of the ribs were then replaced. During the operation, a number of cracks appeared in the brickwork above the rib structure. They formed a regular pattern that corresponded to the calculations. The straight-formed "backsides" of the ribs became clearly visible. All cracks and fissures were filled with a special mortar from above.

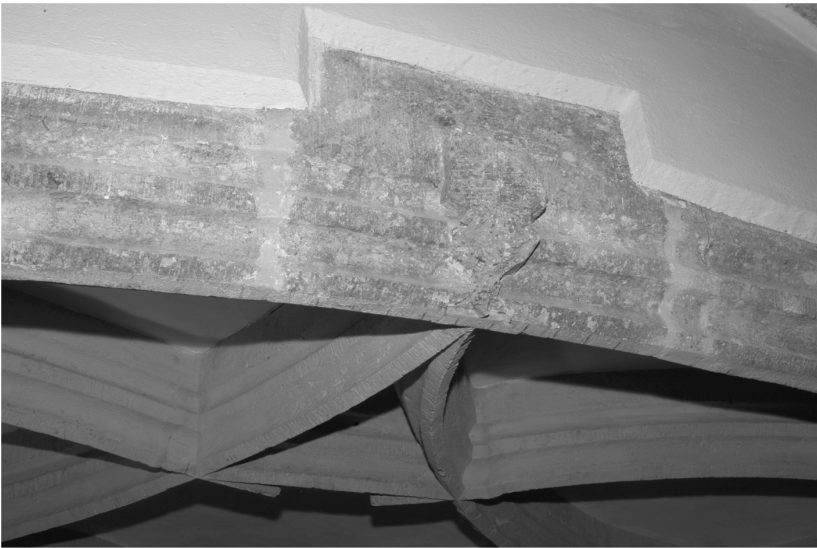
Figure 10. Keystone at the main gate

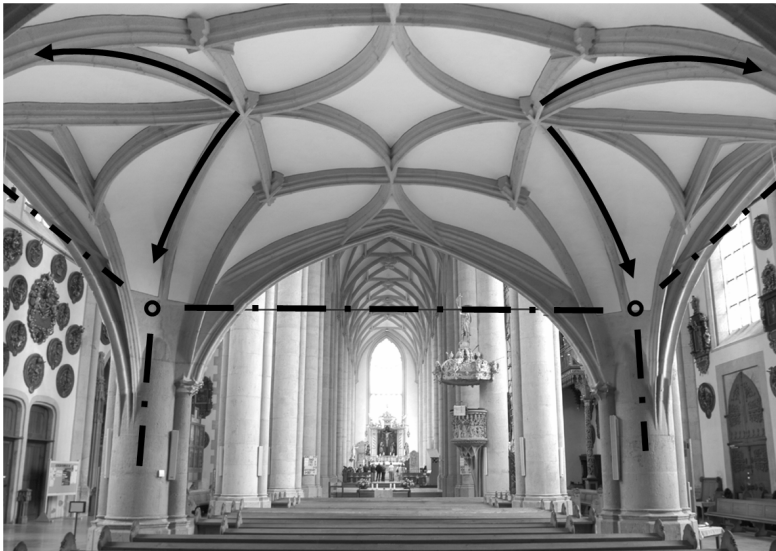
The structure of vault and ribs is based on stringent and logical construction concept. In the area of the Western entrance it could be proved that the concept was consequently implemented. The structural effect in reality follows the intended model. In other areas, the ribs' "frame effect" is certainly also intended. It would be interesting to conduct further research in aspects of the construction. There are still several unanswered questions: do the bent ribs in these areas also have a straight "backside"; does a comparable "keystone" exist in these areas (which would be of considerably larger dimensions!)? The existing tension ties are, as well, a consequent solution (fig.15). The existing ties are of recent date; but probably they act as substitutes for historic predecessors.

Figure 15. Gallery, view to the east side. "Strutted frames" and tension ties
